Manhole Inspection Summary

Manhole # S04II2007MH

Insp Date: **7/19/06 7:08 AM**

Location Address: **3200 LABYRINTH RD**

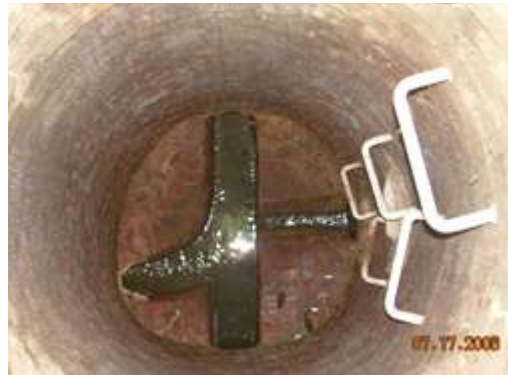
Top View

Infiltration: ☐ None ☒ **Joint** ☐ Cracks ☒ **Mortar** ☐ Roots ☐ Wall

Condition: ☐ Sound ☐ Cracked ☐ Root Intrusion ☐ Loose Brick ☒ **Deteriorated**

Infiltration: ☐ None ☐ Joint ☐ Cracks ☒ **Mortar** ☐ Roots ☒ **Wall**

Adjustment and Corbel infiltration.

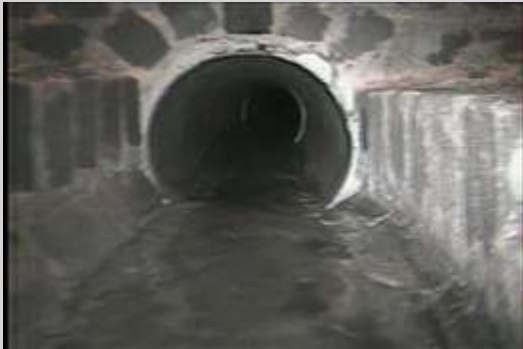
10 in. Circular Gravity Sewer Pipe Out @ 12 O'Clock

Infiltration: **Evidence** Pipe Seal Cond: **Cracked**

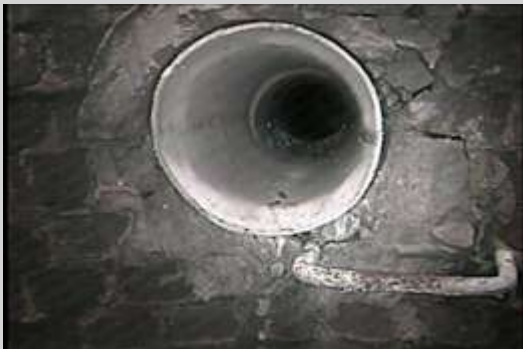
8 in. Circular Gravity Sewer Pipe In @ 3 O'Clock

Corbel deterioration and infiltration.

Infiltration: **None** Pipe Seal Cond: **Cracked**

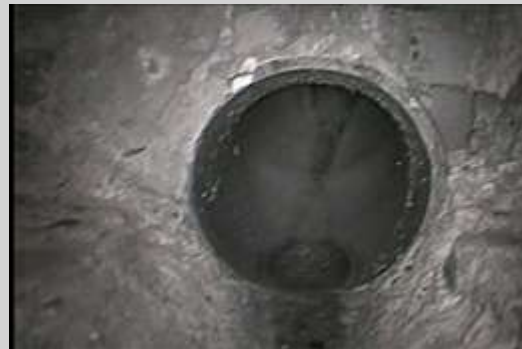
Drop In @ 3 O'Clock

Drop Condition: **Open**

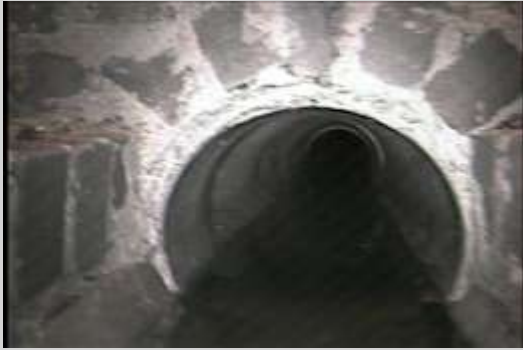
10 in. Circular Gravity Sewer

Infiltration: **Evidence** Pipe Seal Cond: **Cracked**

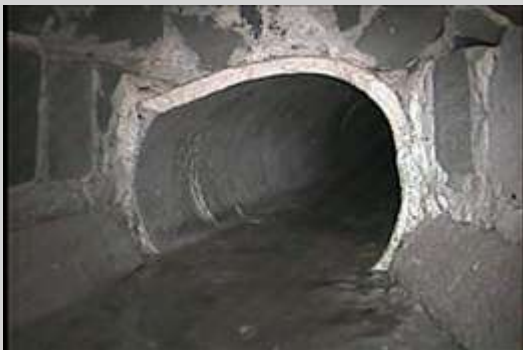
8 in. Circular Gravity Sewer

Infiltration: **None** Pipe Seal Cond: **Cracked**
